# New Construction On Mischief Reef

Analysis By Similarity In Collaboration  
With AllSource Analysis

February, 2021

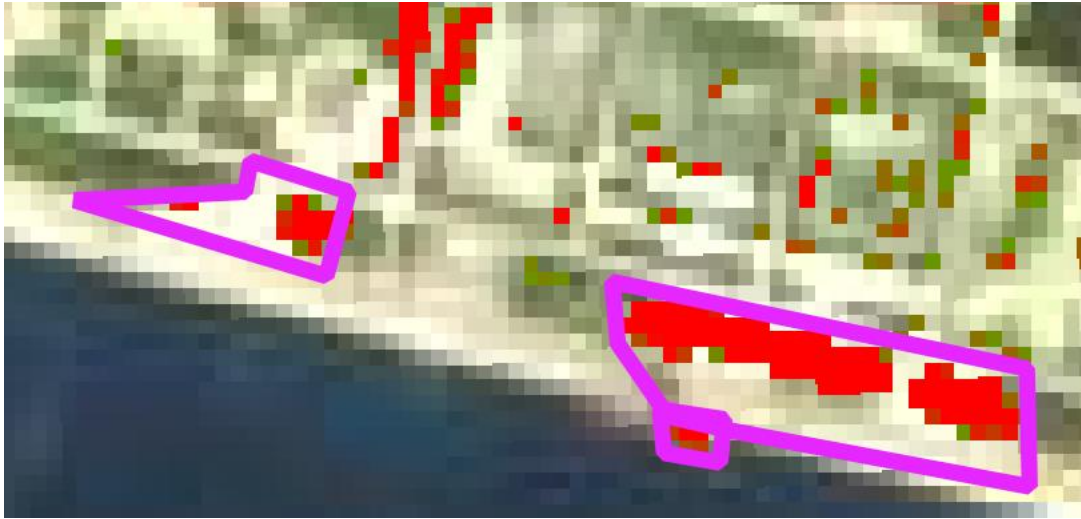
This anomaly heat map, for sites 5 and 6 in the analysis that follows, was generated by AIADS. It is shown overlaid onto a Sentinel 2 image. The anomalies are the red squares. After reviewing the imagery, our analyst then drew the pink polygons around the areas that need further investigation.

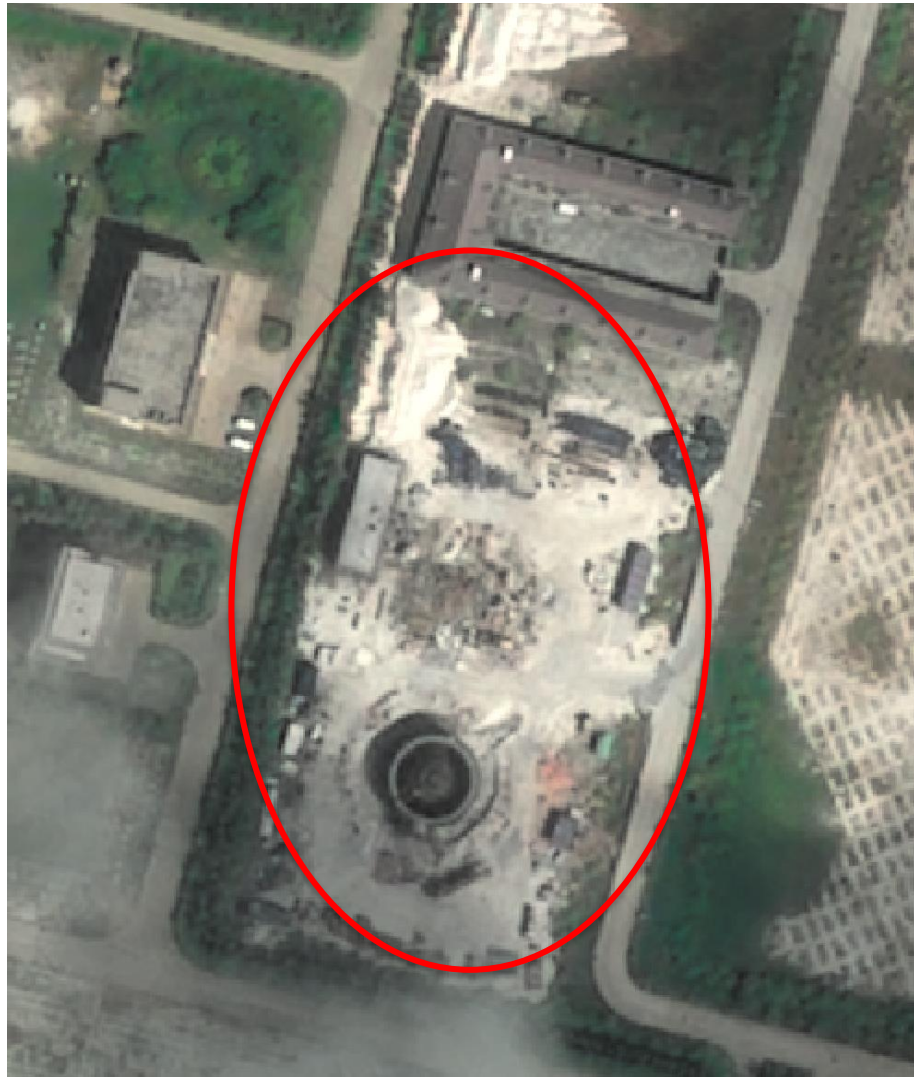
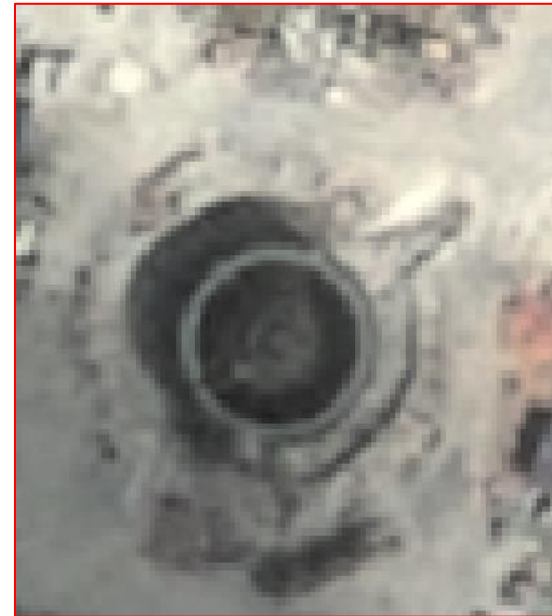
# Mischief Reef, February 4, 2021

Construction of a permanent cylindrical structure 16 meters in diameter started in early December 2020. This is a possible antennae mount structure.

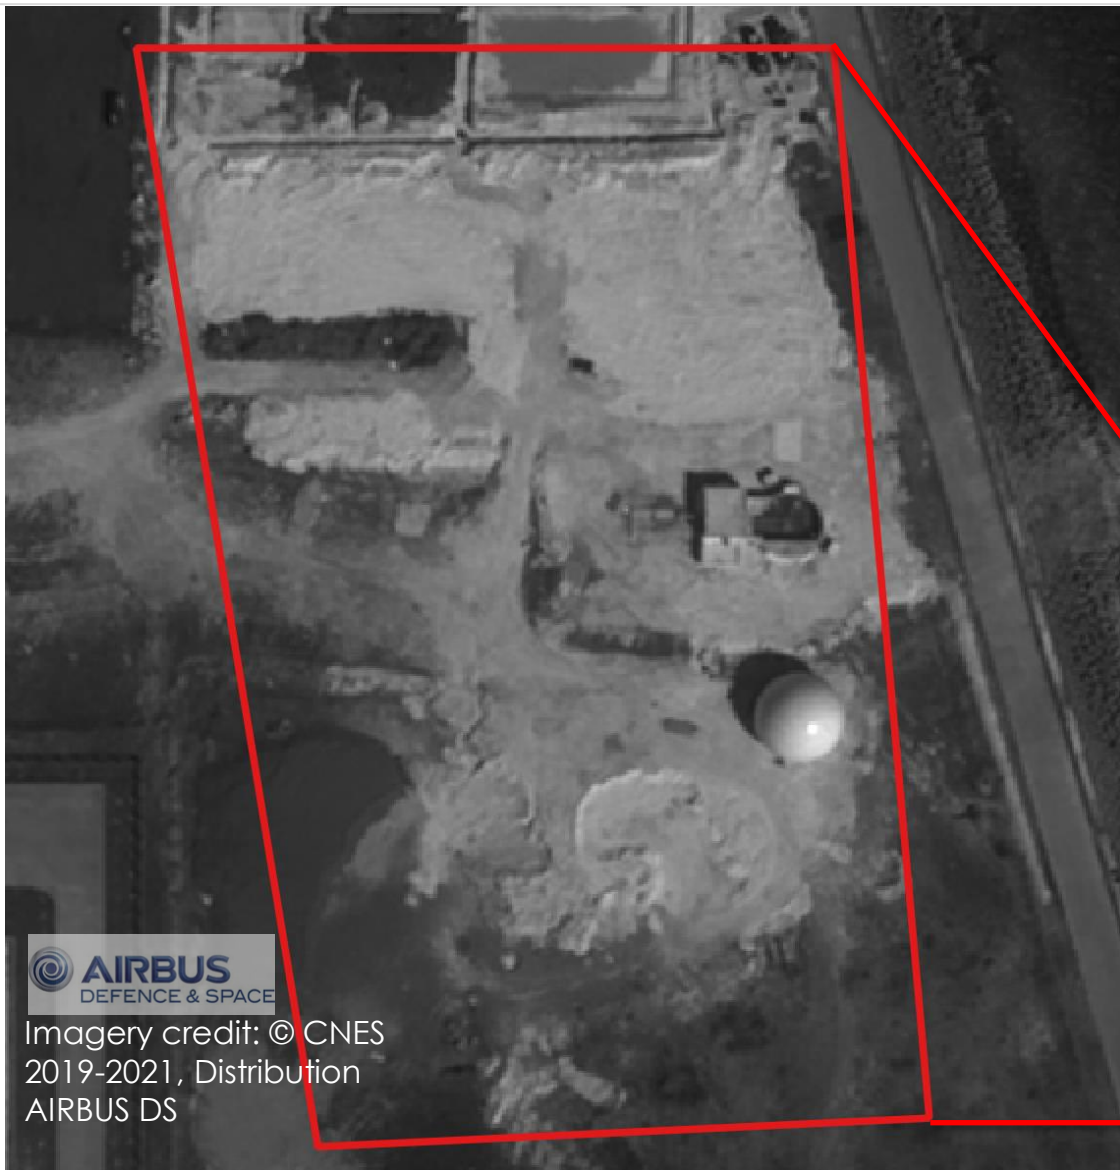
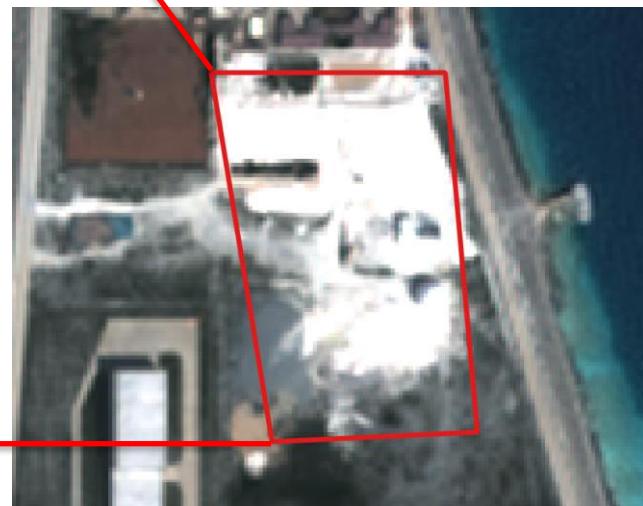
Site Number 2

This area has been cleared, and AllSource observed a structure: a concrete structure (9.90565, 115.50053) with a large radome cover located 20 meters to the south (9.9053, 115.5006).

These objects appeared between October 22 and November 23, 2020. The concrete structure may have undergone additional internal construction between November 23 and February 1, 2021. This is possibly a fixed radar structure.

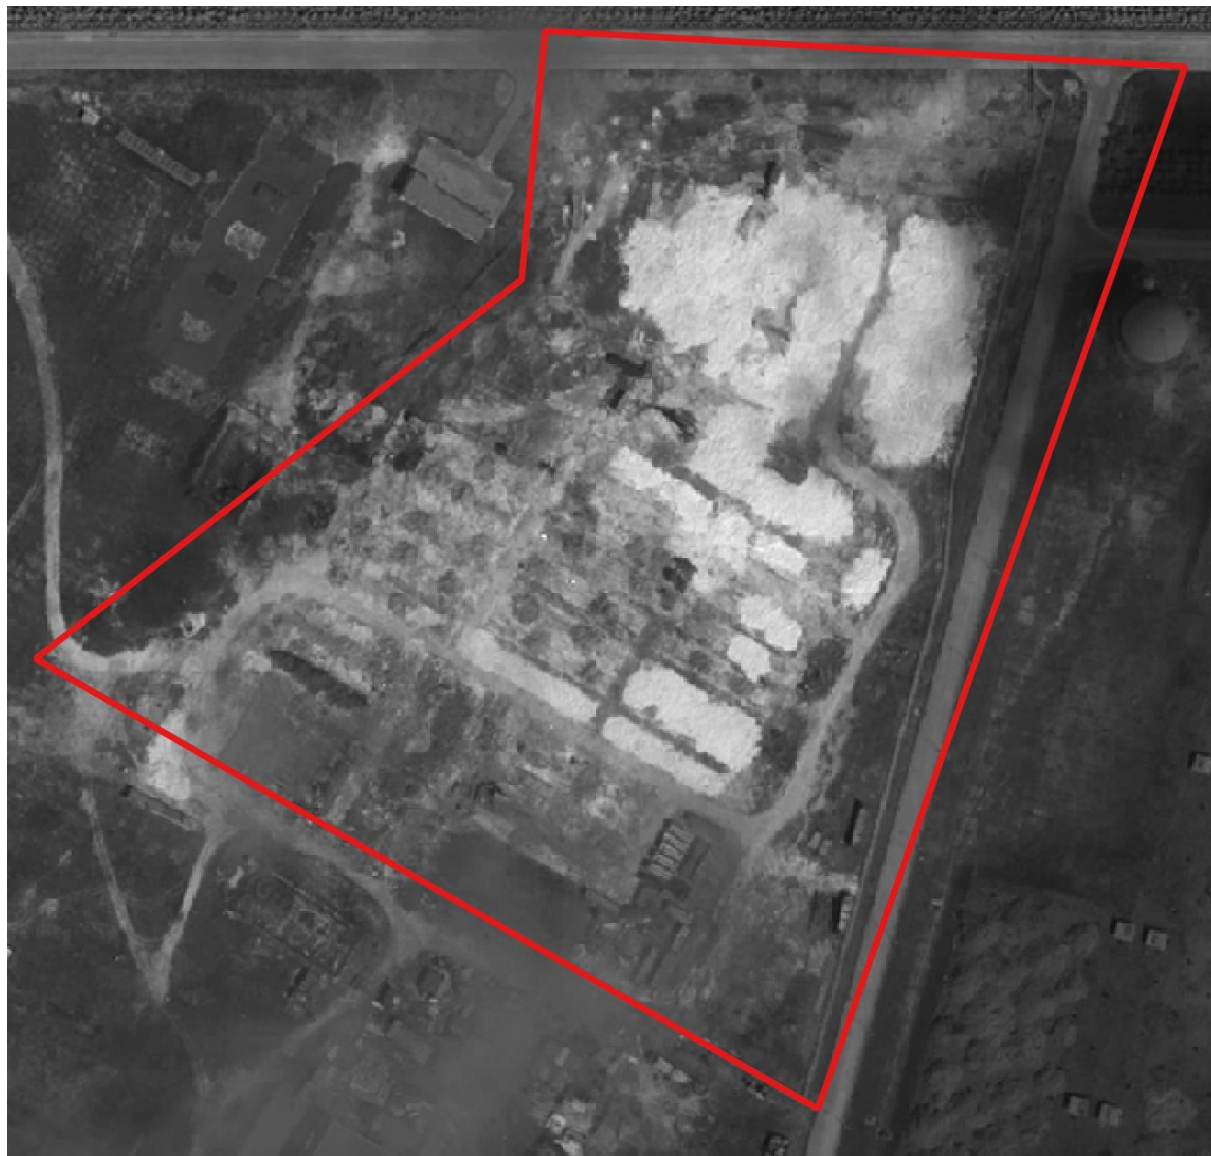
# Mischief Reef, February 4, 2021

This area has been cleared (9.93244, 115.51593), with no indication of preparation for additional construction.

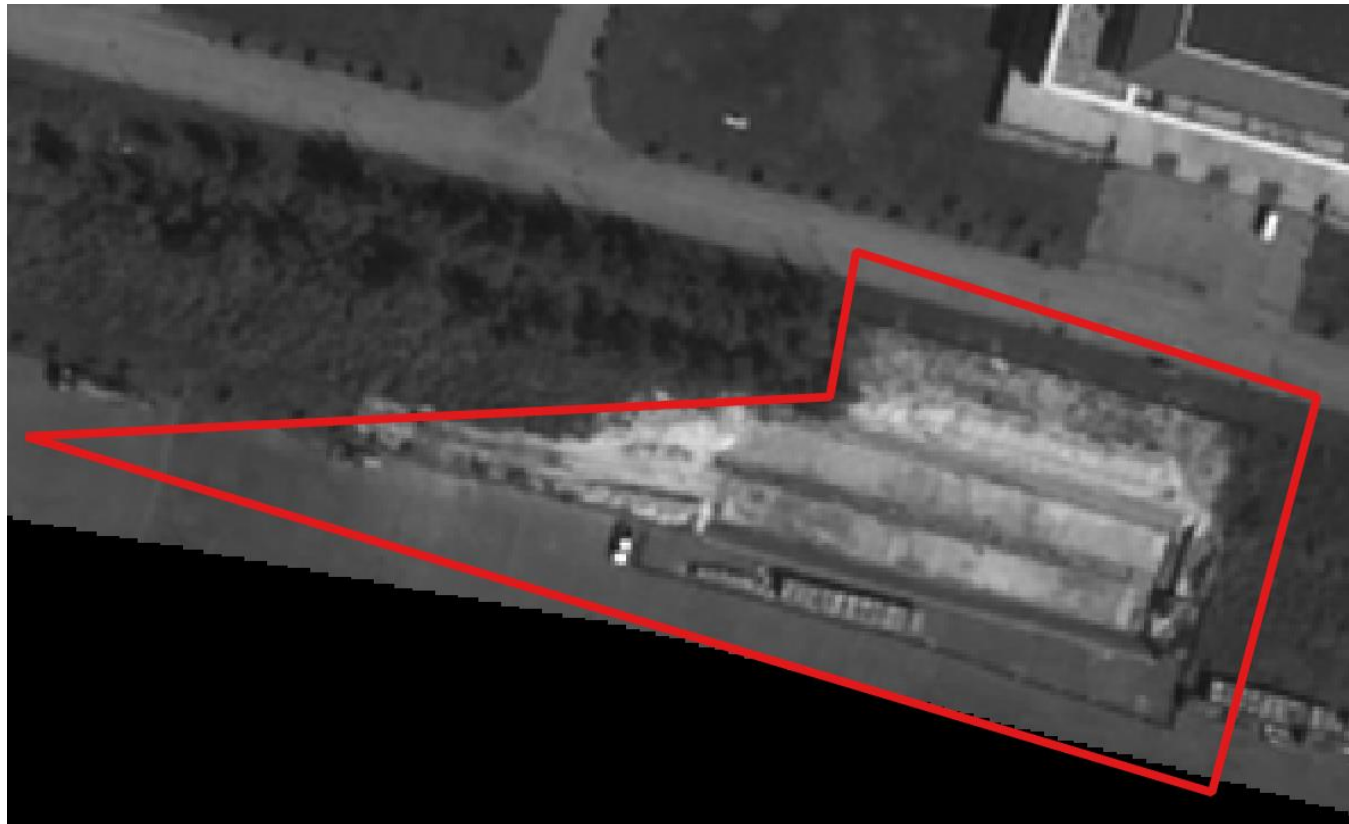
# Mischief Reef, February 4, 2021

This appears to be a new area of possible construction portside, started between October 22 and November 23, 2020.

There appears to be construction equipment and a raised, rectangular area constructed adjacent to the port quay.

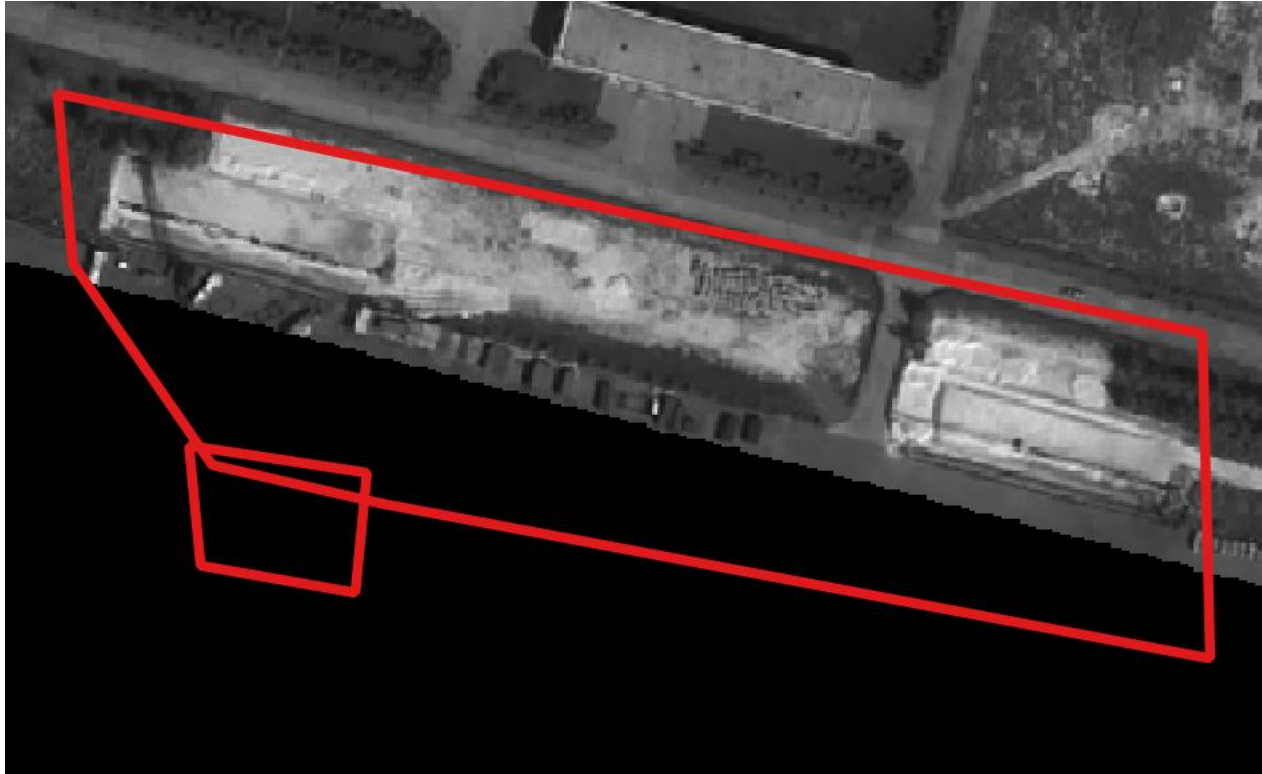
# Mischief Reef, February 4, 2021

This appears to be a new area of possible construction portside, started between October 22 and November 23, 2020.

There appears to be construction equipment and a raised, rectangular area constructed adjacent to the port quay.

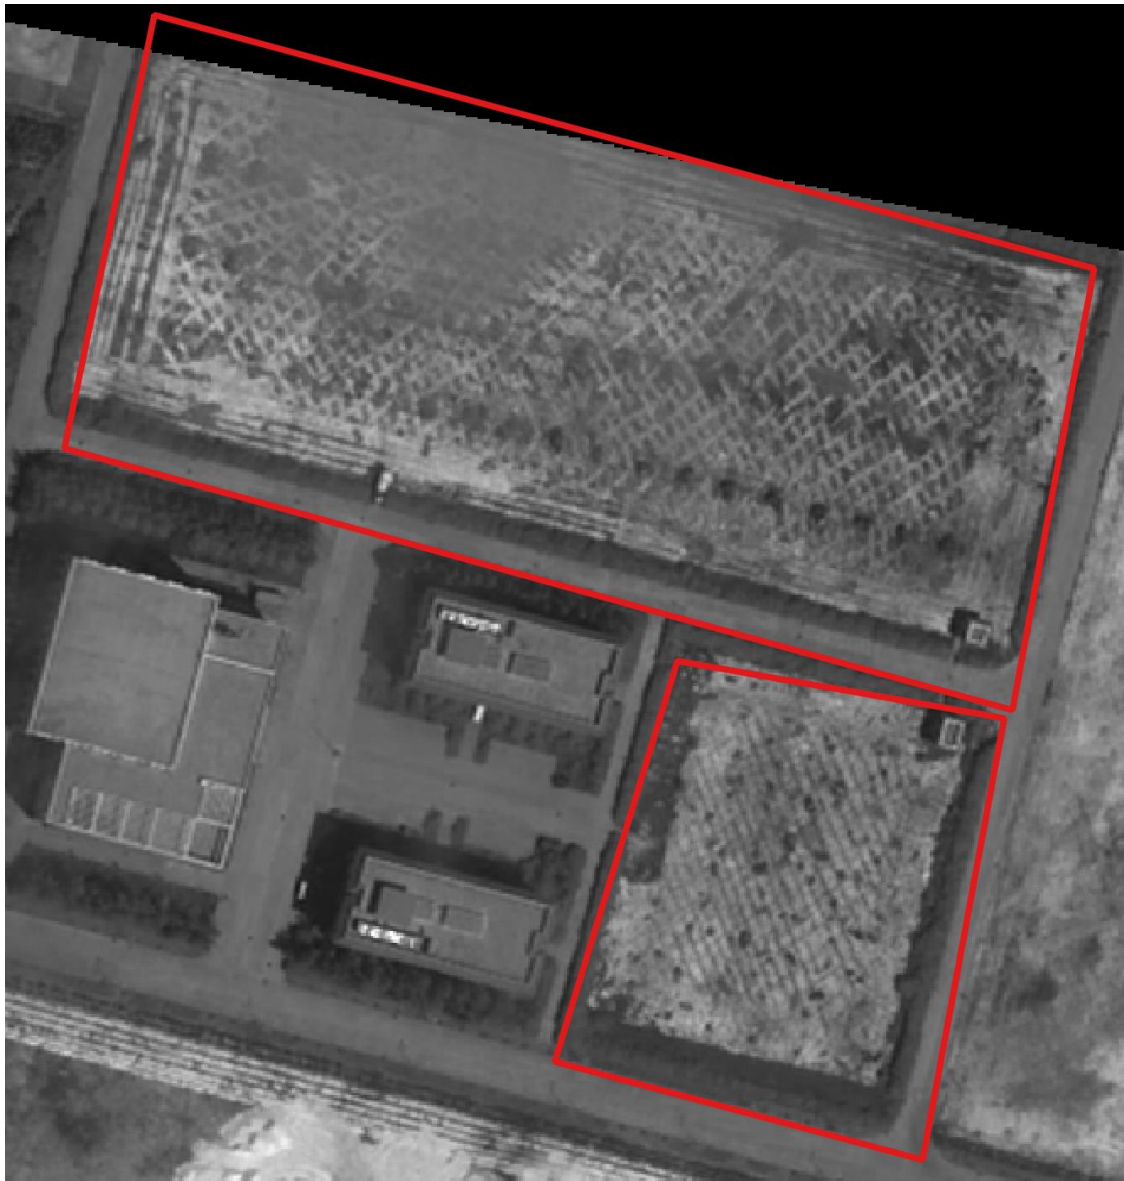
# Mischief Reef, February 4, 2021

This area has been cleared, with no indication of preparation for additional construction.
