# Construction Activity On Subi Reef December 2021 to May 2022

Subi Reef, occupied by the PRC, is just 13 nautical miles from  
Philippine-occupied Pag-asa (Thitu) Island

Analysis By Similarity  
May, 2022

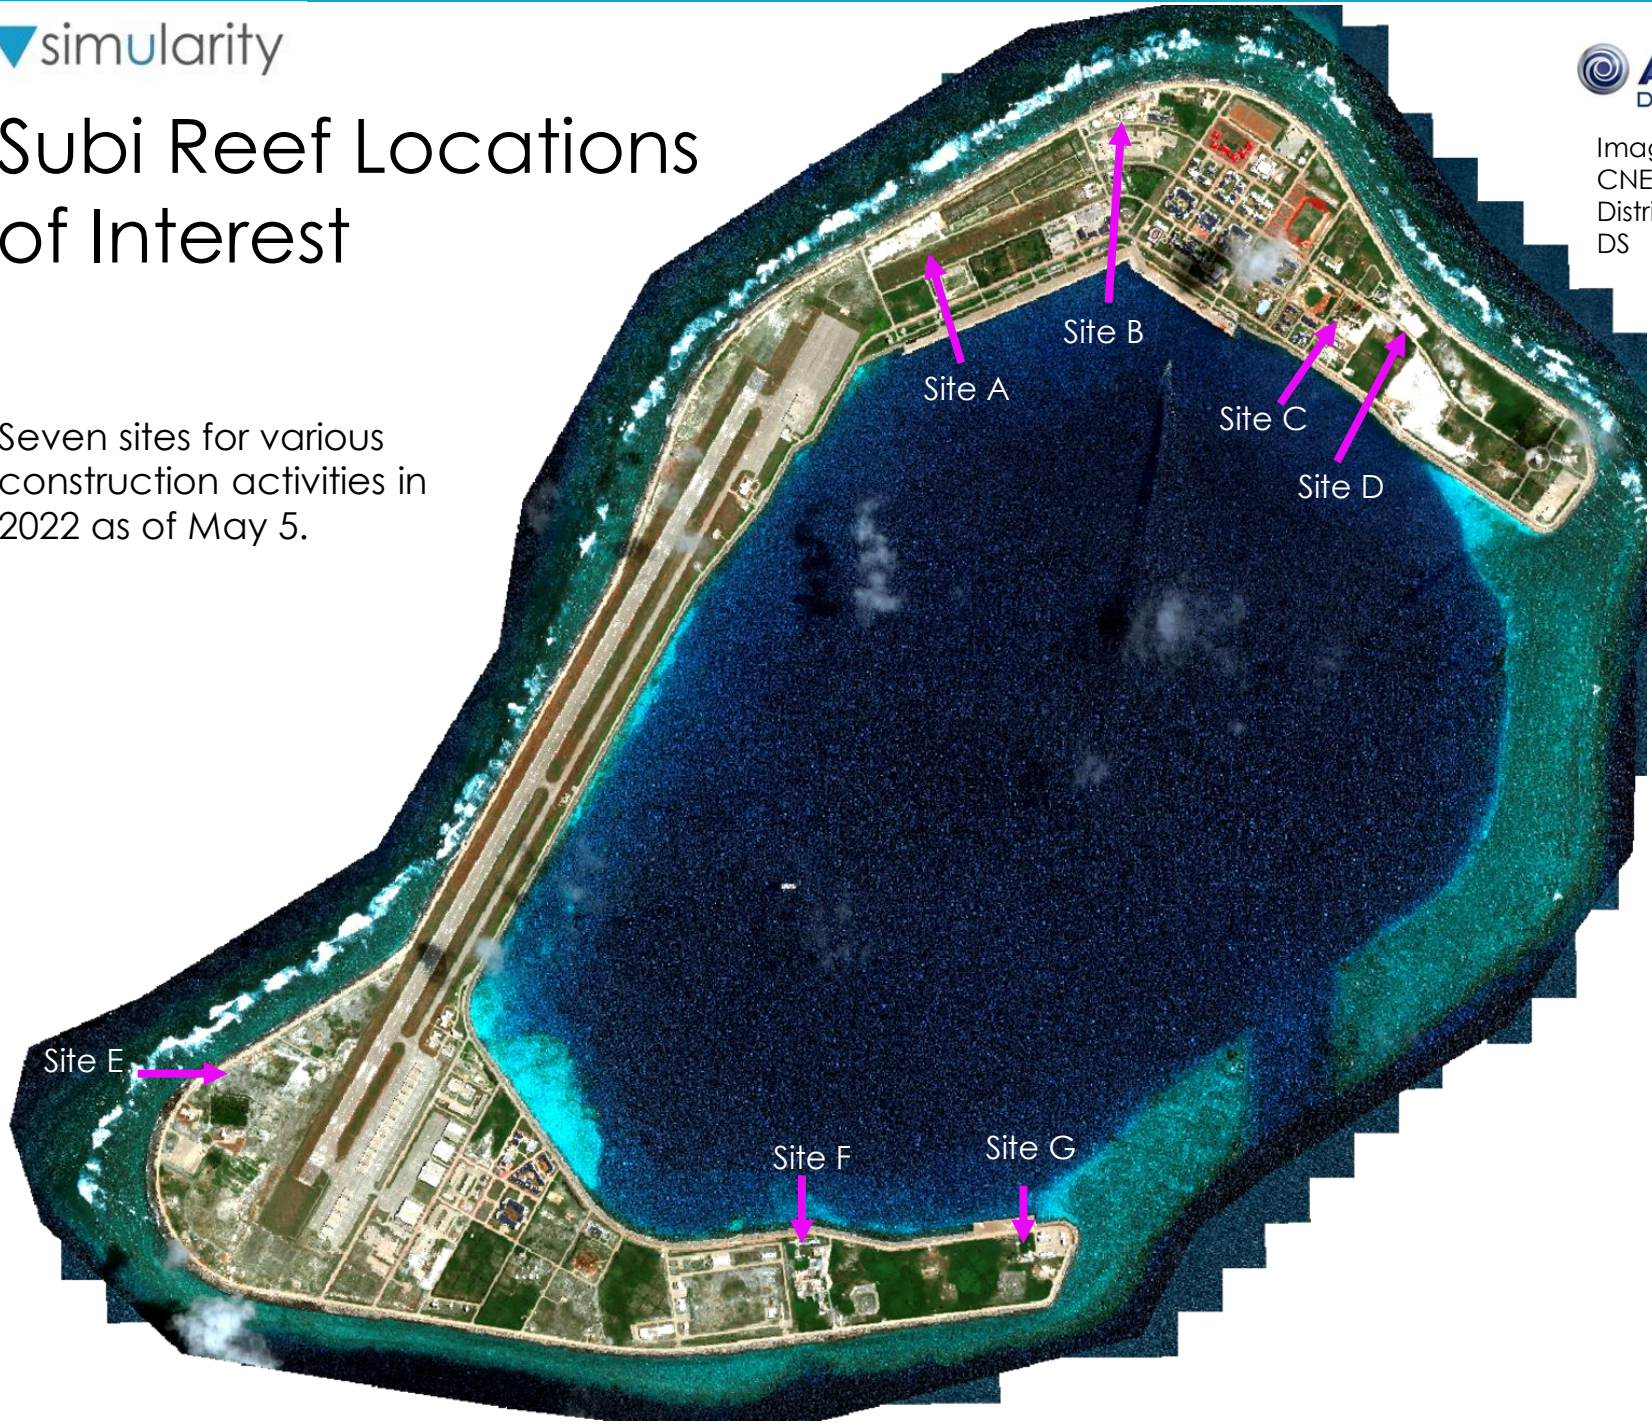
# Subi Reef Locations of Interest

Seven sites for various construction activities in 2022 as of May 5.

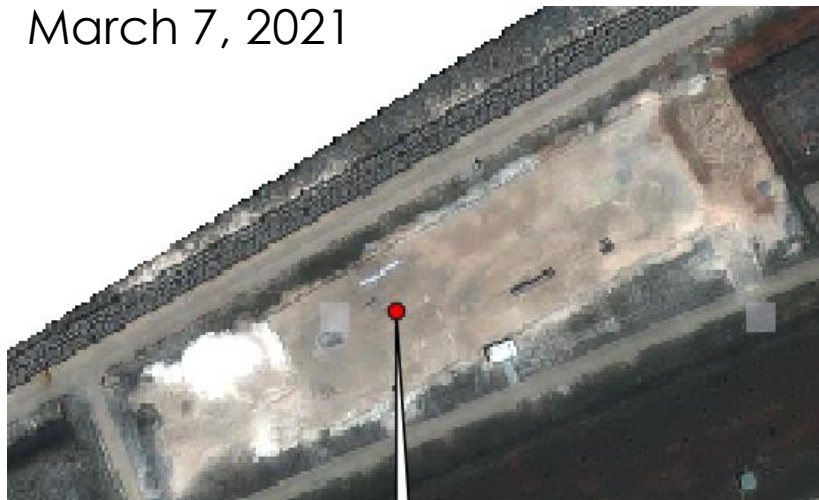
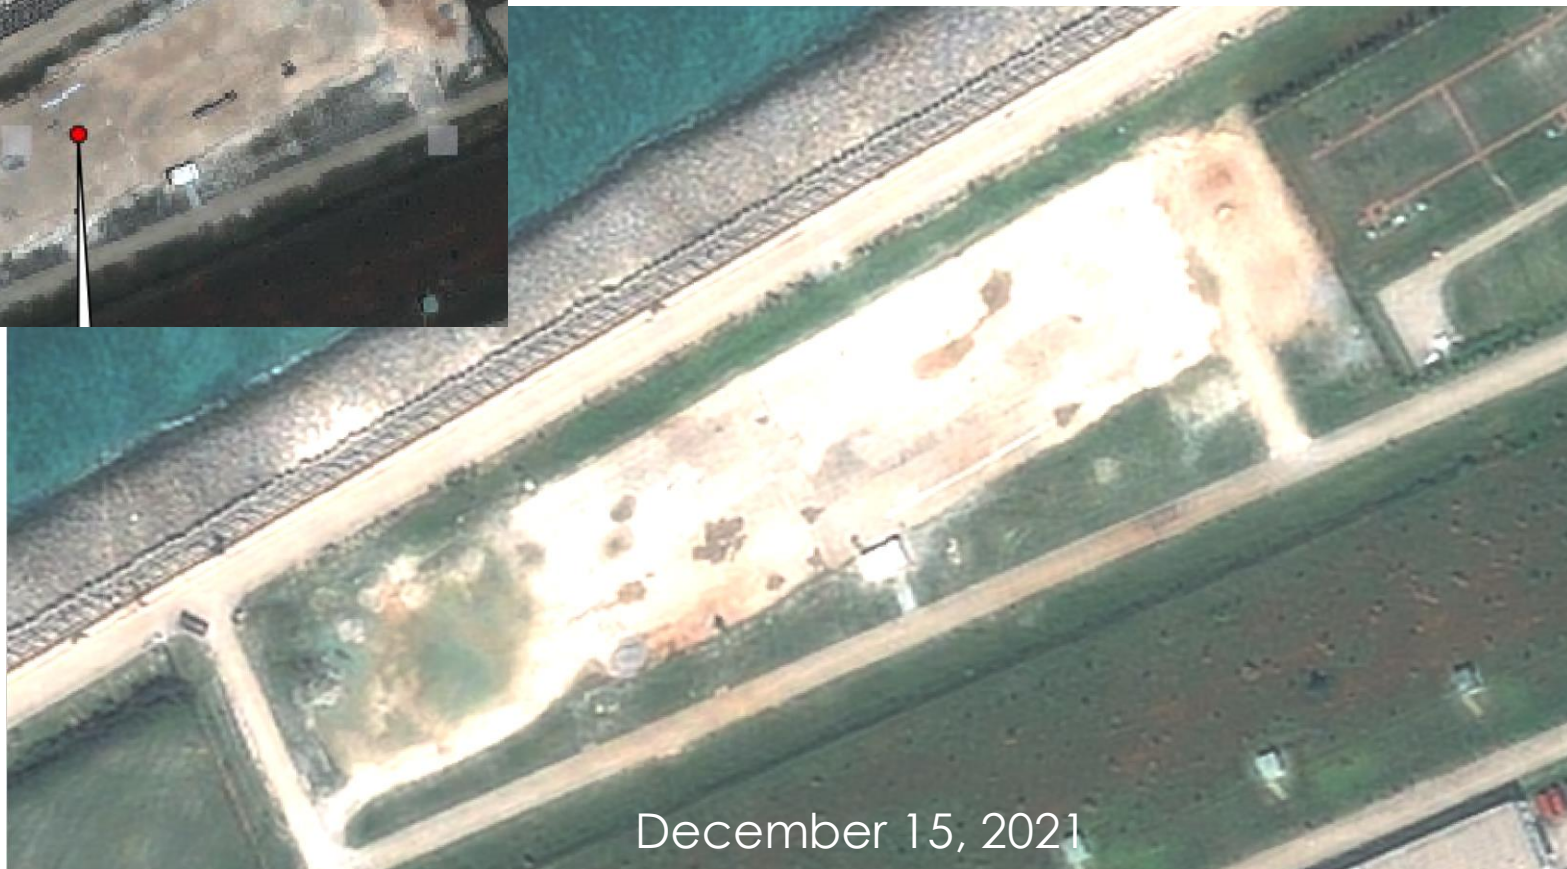
# Subi Reef Site A

Addition of sand, access paths, and a more geometric shaped probable foundation for construction between March and December 2021

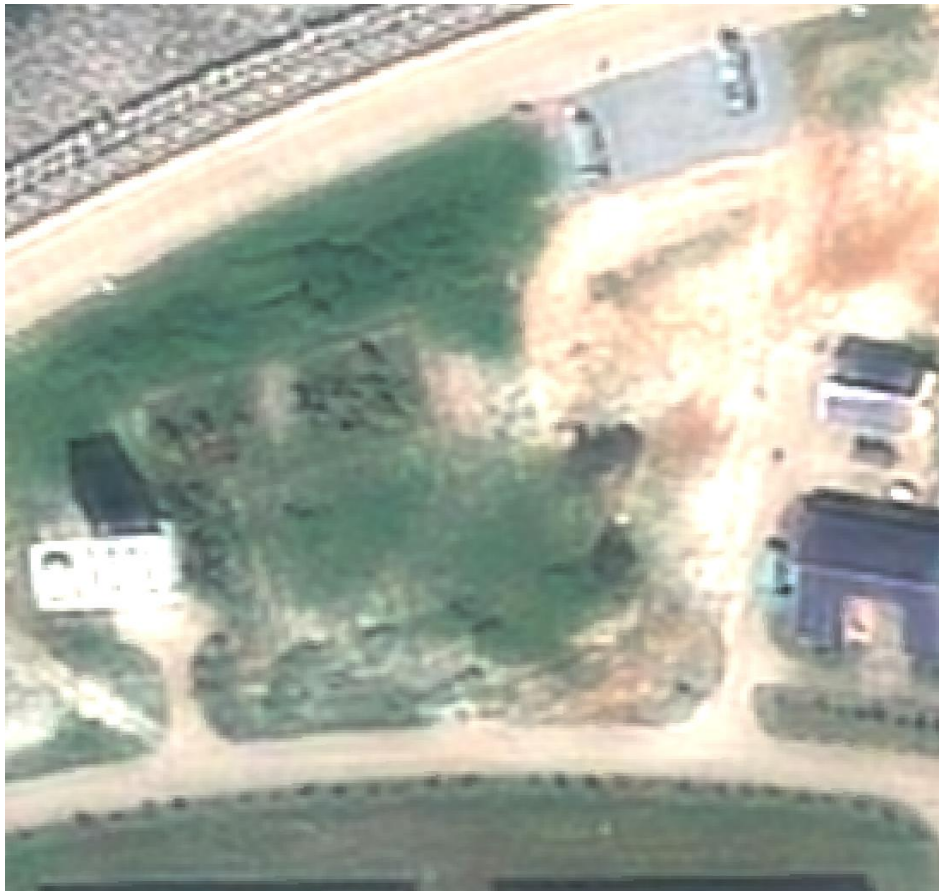
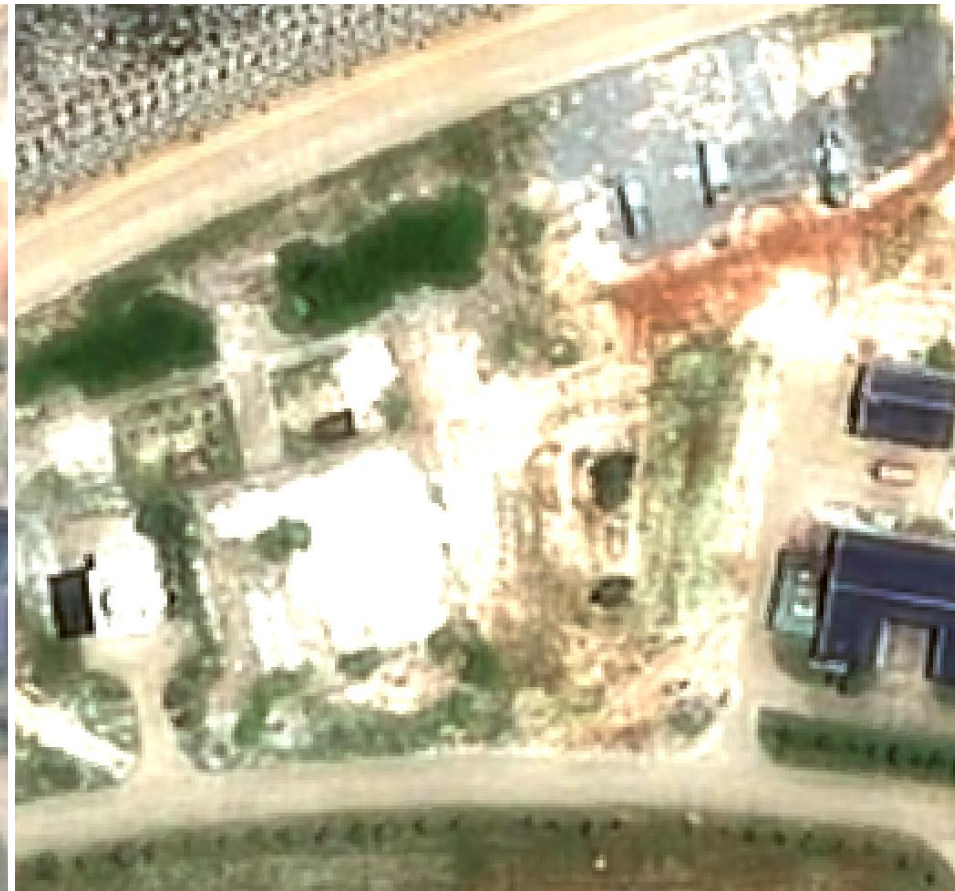
# Subi Reef Site B

Land clearing, apparent paths to road and materials stockpiles in progress, addition of sand, appearance of materials (rust colored, white, and gray) and equipment (rectangles near road are likely trucks that brought materials). Emerging white square shape may be a foundation.

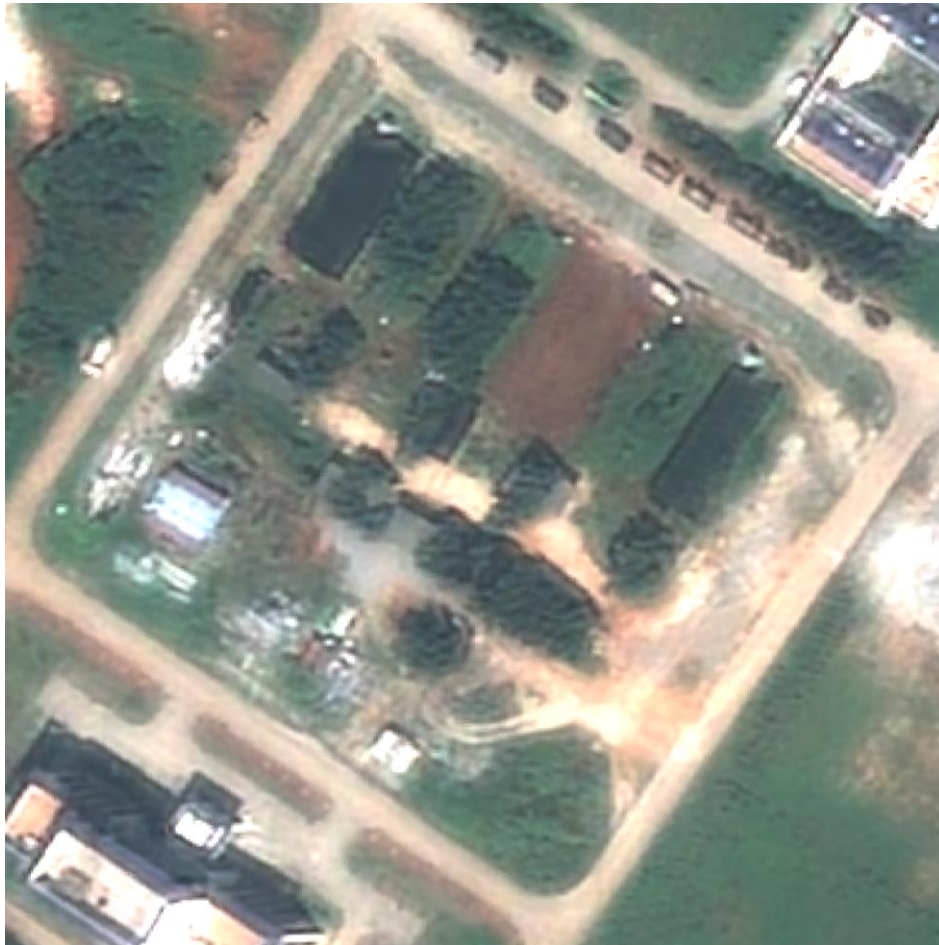
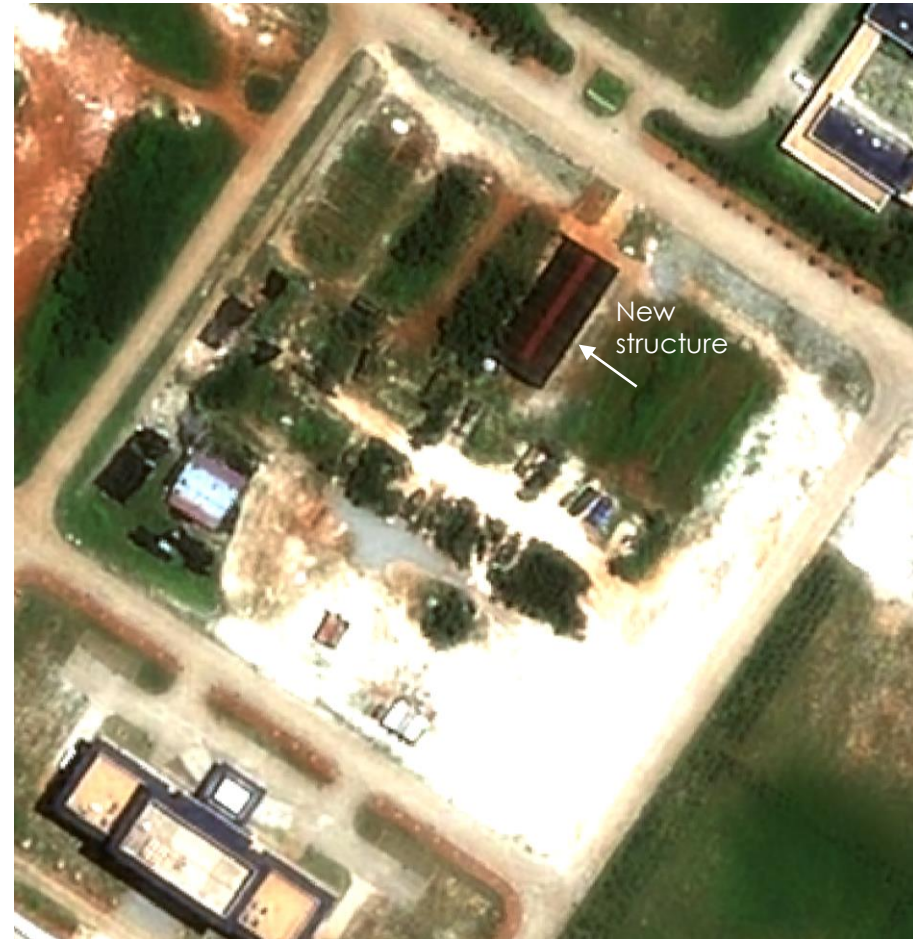
# Subi Reef Site C

Two green rectangular structures removed, brown central structure with red stripe constructed, path from road to central structure added, addition of significant amount of sand. The sand, trucks and/or storage containers (along inner strip of sand) may indicate construction is still in progress.

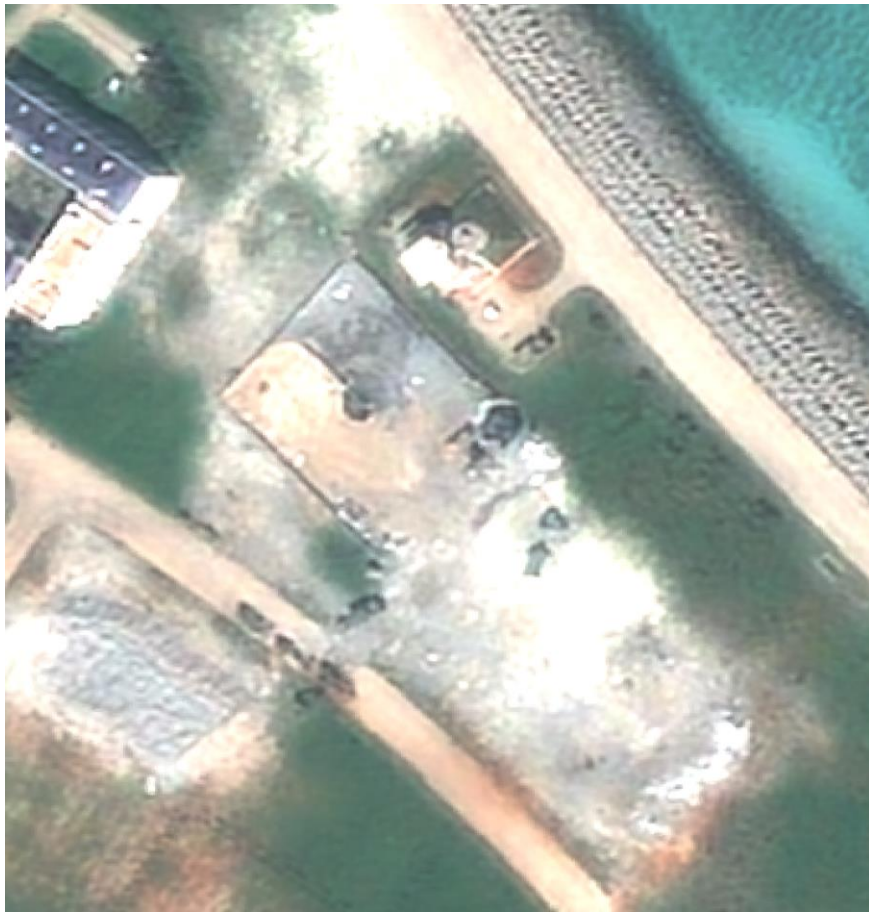
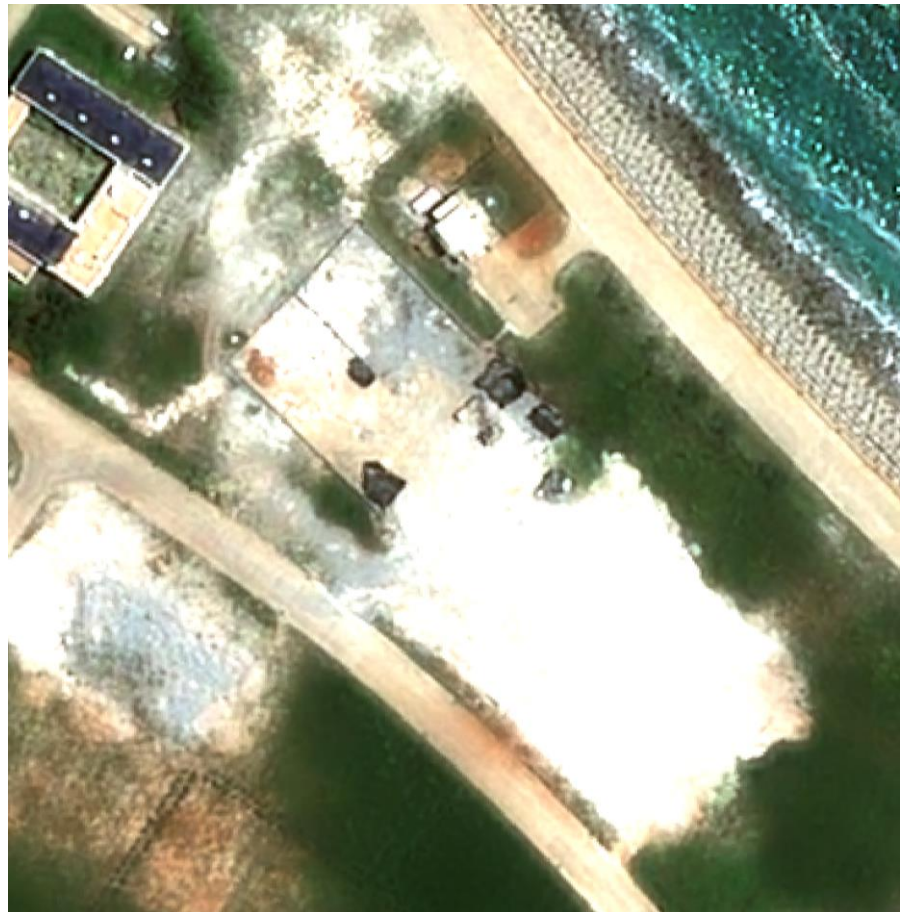
# Subi Reef Site D

Presence of probable construction equipment (black colored), trucks (rectangles on road in first image), and materials (lumpy gray, rust colored, and white), addition of significant amount of sand. Emerging white rectangular shape indicates probable foundation.

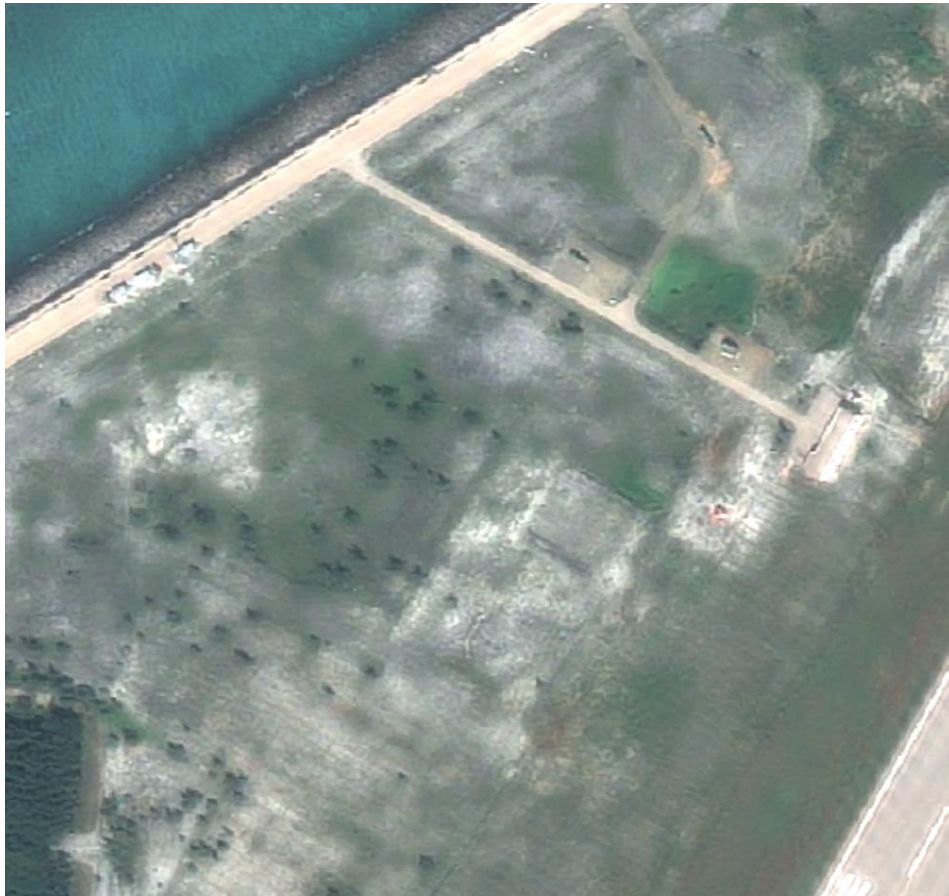
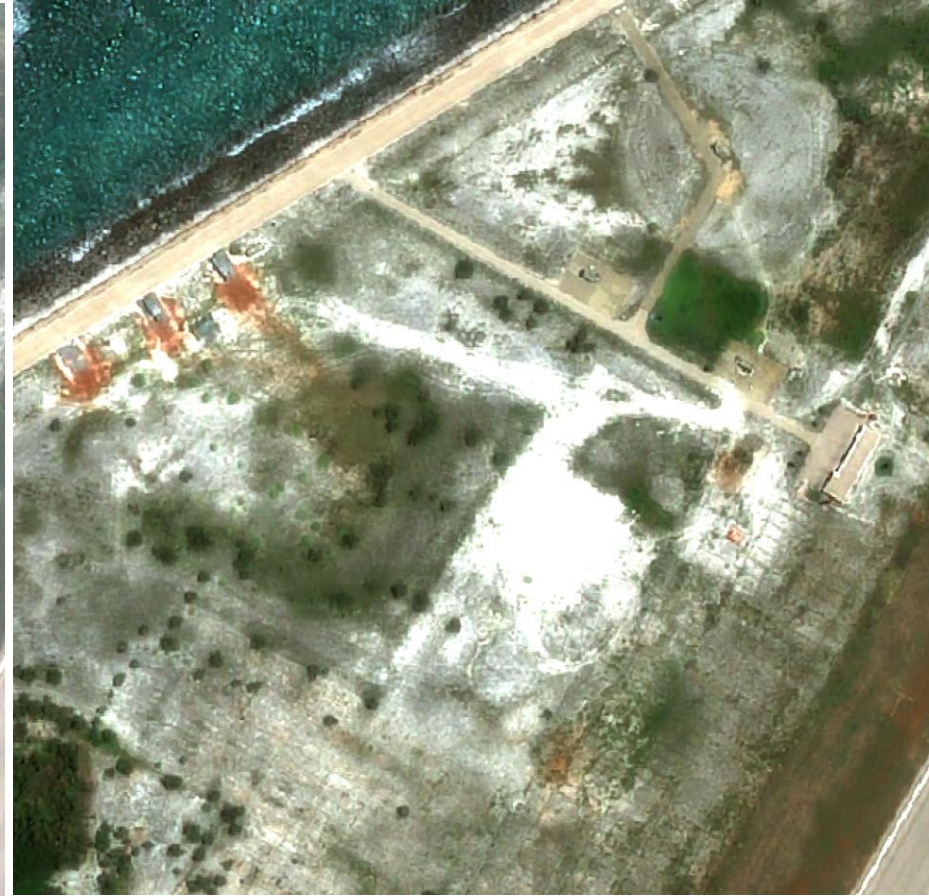
# Subi Reef Site E

Presence of structures and materials (rust-colored stockpiles), addition of significant amount of sand. Paths created to road and to location of material stockpiles are likely to facilitate use of heavy equipment. Emerging white squarish shape indicates possible foundation.

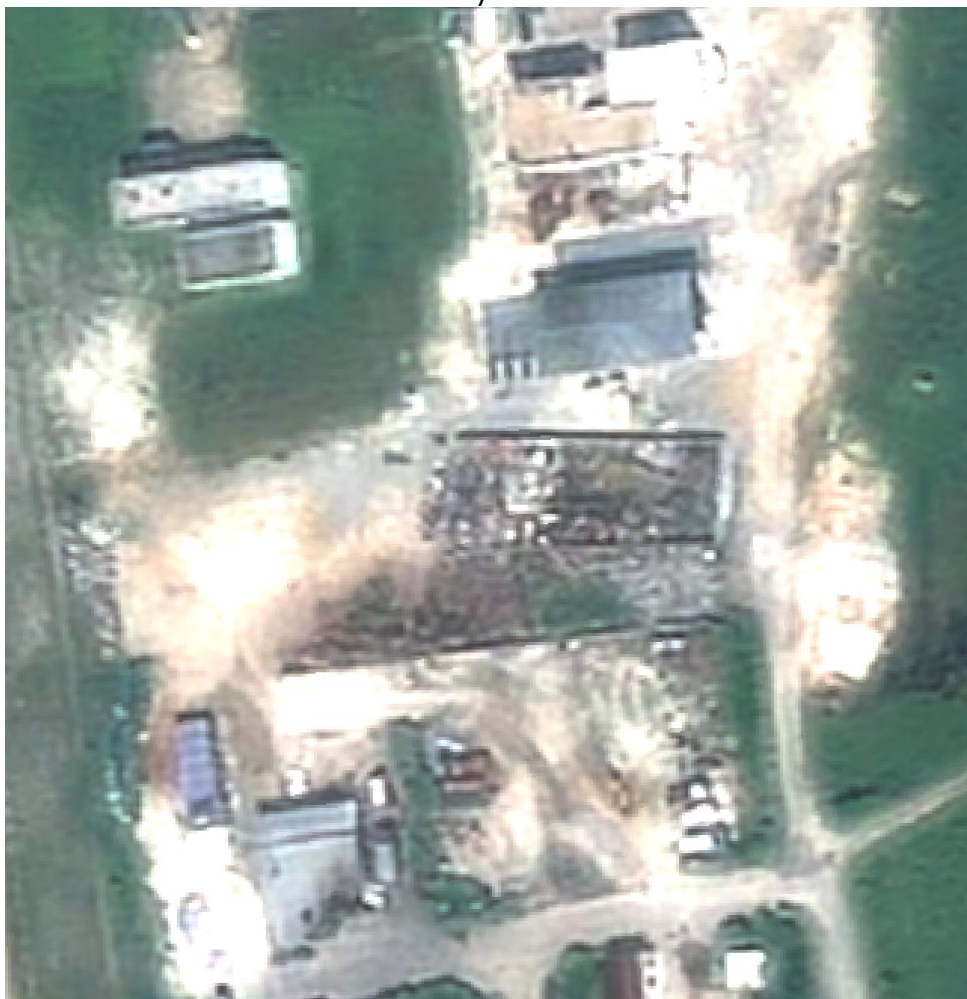
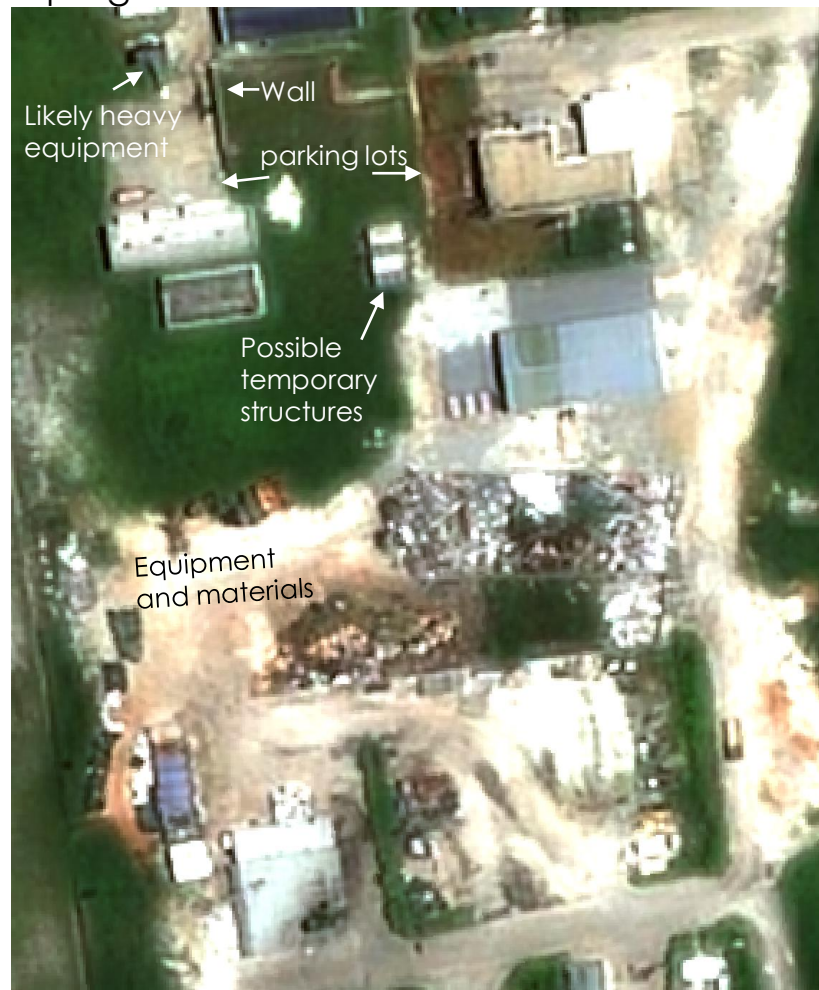
# Subi Reef Site F

New wall and parking lots, and new possible temporary structures. Presence of equipment and additional materials may indicate construction is still in progress.

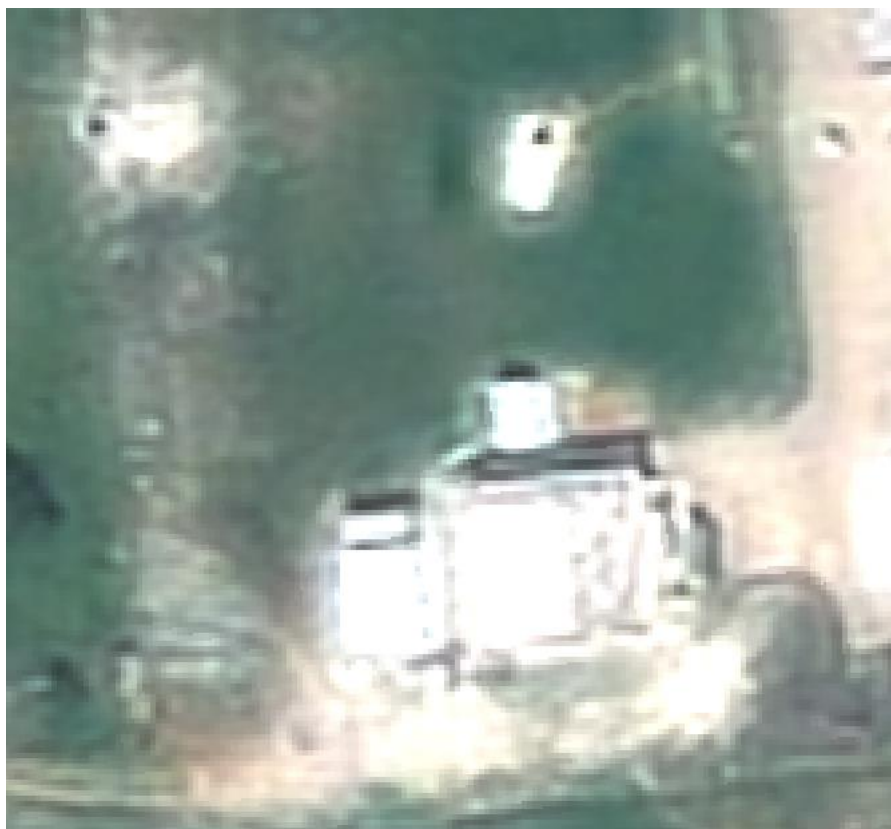
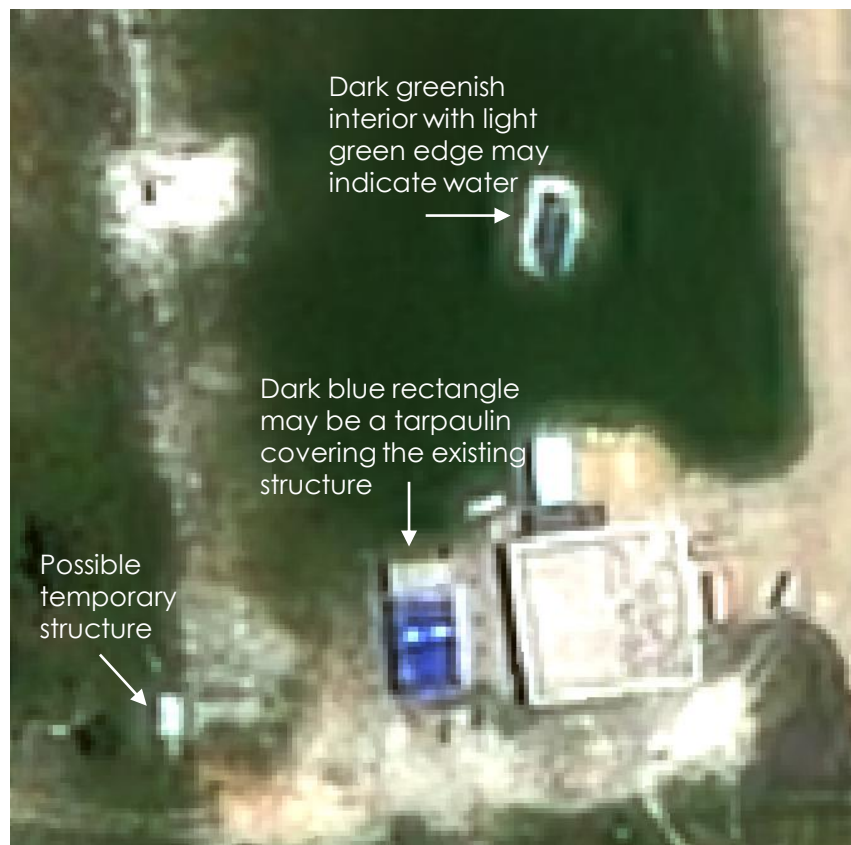
# Subi Reef Site G

Changes to existing site may indicate maintenance, expansion, or addition of new features.
